Phase I Environmental Site Assessment

Bell Oasis II
Portion of 5600 Rickenbacker Road
Bell, California

January 17, 2022

January 17, 2022
Project No.: 21-12270

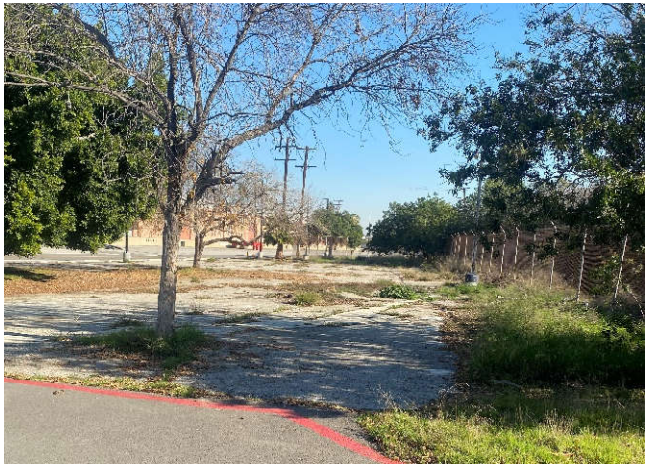
Photographs 1-4

Photograph 1. View of the eastern portion of the subject property, facing west.

Photograph 2. View of the western portion of the subject property, facing east.
